**Flood Control Project Maintenance  
Levee Inspections**  
**LMA District Cover Sheet**  
**Spring 2020 Levee Inspection Results**

**Reclamation District No. 1001 Nicolaus**

**Spring 2020 Levee Inspection Results**

**Levee Inspection Report By Mile - Spring 2020**

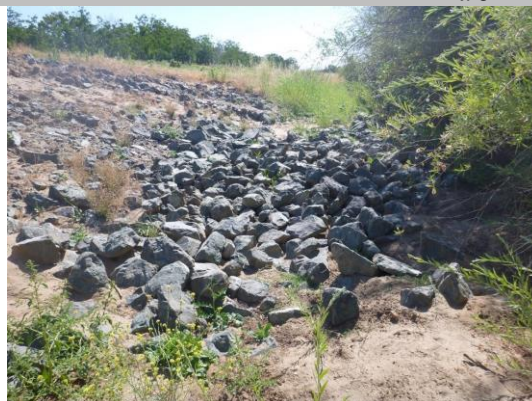
Photo 3 of 3 : LEVAL\_SP\_2020\_135\_303.jpg

LM Start	0.73	Rating **	A/W	Issue No.	9 (cont)	
LM End	0.75	Issue Type +	Ma	Location *		
Category	Supplemental			GPS Latitude/Longitude		
				Start	End	
Item	2017 Storm Damage			38.975046 °	38.975038 °	
				-121.480938 °	-121.481151 °	
DWR ID	LMA-15

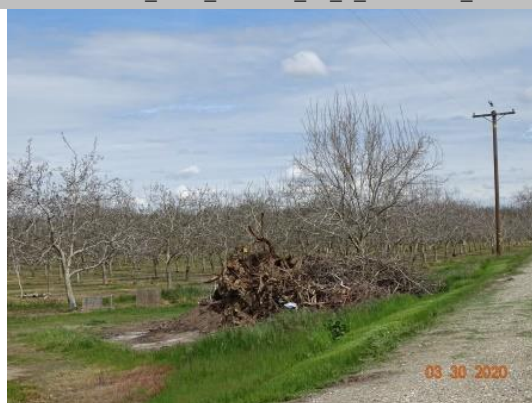
Photo 1 of 1 : SP\_2020\_RD1001\_36\_7\_20200406\_00018.jpg

LM Start	0.98	Rating **	C	Issue No.	18
LM End	0.98	Issue Type +	En	Location *	LS
Category	Earthen Levee			GPS Latitude/Longitude	
				Start	End
Item	Encroachments			38.974284 °	38.974284 °
				-121.485362 °	-121.485362 °
DWR ID	DWR_RD1001_01_f _ 2018_18				
Comment Code					
PR : Prunings					
Inspector Comment					
Prunings hae been removed off the levee toe, Spring 2020.

View of the landside looking upstream at prunings stacked up at the levee toe, Spring 2020.

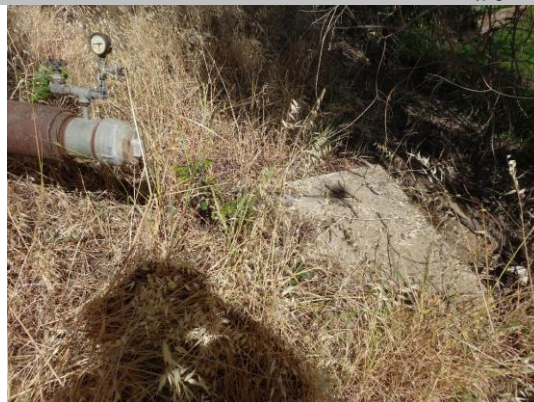
Photo 2 of 3 : UCIP\_SP\_2020\_41673\_22744.jpg

Comment Code					
Inspector Comment					
DS_ID:22536 FS_ID:41673 EP_NO: 5562 Repair Type: Non-Urgent Crossing Status: Found UCIP Comments: 05/23/2013 Pipe appears abandoned and if so should be done so properly. WS pipe plugged with stopper. Seems abandoned. Only abandoned pump base found. (P. Amatya - DWR UCIP) FIELD_STRUCT_DESC: 6-inch coated steel irrigation pipe through the levee, 3.5 feet below the crown. Metal cutoff collar placed on the pipe at the center of the levee crown. Pump was removed. Pump base on the waterside (WS) berm. Shutoff valve on the discharge side of the pump. Foot valve below water on the intake side of the pump. Siphon breaker on the landside (LS) shoulder. Pipe discharges into underground irrigation system on the LS. Power pole and meter box, 10 feet from the landward toe. 1.5-inch flexible conduit through levee, 3.5 feet below the crown. (Pump and 6-inch irrigation pipe authorized under Permit No. 5562, 1966 - Samuel B. Single). [Additional Reference(s): DWR Levee Log, 1993]. FS Date: 5/23/2013

WS- plugged pipe and pump base.

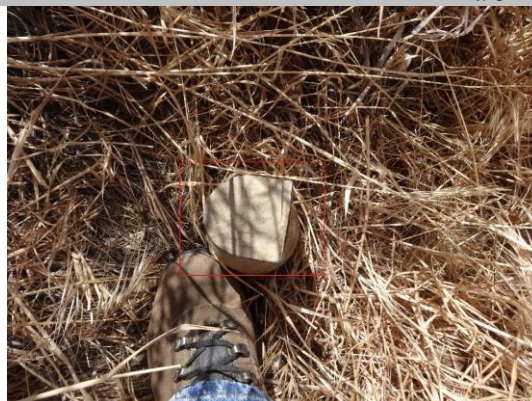
Photo 3 of 3 : UCIP\_SP\_2020\_41673\_22743.jpg

LS- only pipe air vent found on levee slope.

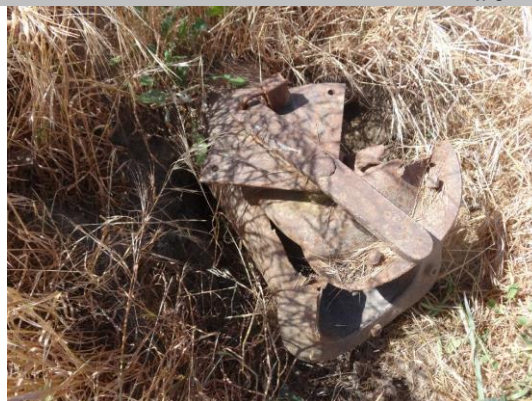
Photo 1 of 3 : UCIP\_SP\_2020\_50740\_22753.jpg

DS\_ID:22529  
FS\_ID:50740  
EP\_NO: 2281  
Repair Type: Non-Urgent  
Crossing Status: Not Found  
UCIP Comments: 01/17/2019 Records detailing the actions taken for the removal of the 7-inch pipe were recorded under file name LI10703\_79259 document 20141008 CVFPB letter of acknowledgement available through permit records. (O. Magana - DWR UCIP)  
07/13/2016 According to district president Joe Henderson, pipe was removed 2-3 years ago. No permit for removal found or evidence of pipe or its removal found. (K. Fazel - UCIP)  
05/23/2013:- leaky pipe end and erosion on WS.- cracked dirt mound on LS - seems not been used for some time. (P. Amaty - DWR)  
FIELD\_STRUCT\_DESC: \*REMOVED\* 7-inch steel irrigation pipe through the levee, 1.9 feet below the crown. Portable pump mounted on the bank during the summer months. Control valve on the waterside (WS). Steel plate bolted on the WS end during the winter months. Pipe discharges into a 30-inch concrete standpipe at the landside (LS) toe. (Pump and 7-inch irrigation pipe authorized under Permit No. 2281, 1956 - Willard R. Brown; 7-inch pipe through levee and concrete standpipe located on LS were removed as part of the 2013 USACE Periodic Inspection). [Additional Reference(s): DWR Levee Log, 1993].

WS- end of the pipe.

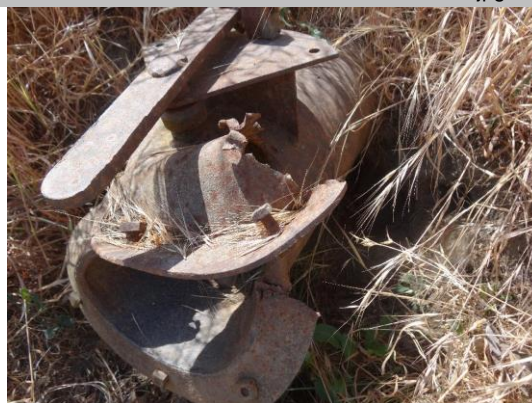
Photo 3 of 3 : UCIP\_SP\_2020\_50740\_22751.jpg

WS- due to water leak, soil around pipe eroded.

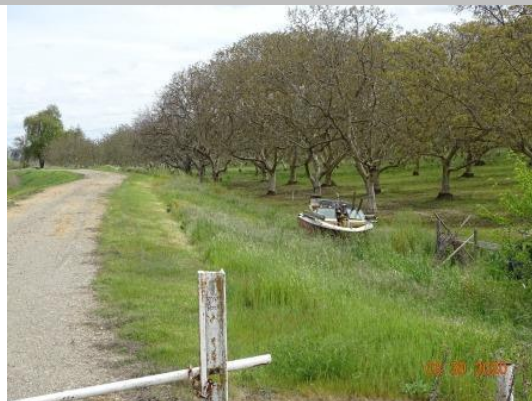
Photo 1 of 1 : SP\_2020\_RD1001\_35\_19\_20200406\_00026.jpg

LM Start	0.53	Rating **	M	Issue No.	19
LM End	0.53	Issue Type +	En	Location *	LS
Category	Earthen Levee			GPS Latitude/Longitude	
				Start	End
Item	Encroachments			38.974371 °	38.974371 °
				-121.481223 °	-121.481223 °
DWR ID	DWR_RD1001_02_f_2016_19				
Comment Code					
AV : Abandoned vehicles					
Inspector Comment					
Remove boat parked at the landside levee toe, Spring 2020.

View looking upstream of a boat at the landside levee toe, Spring 2020.

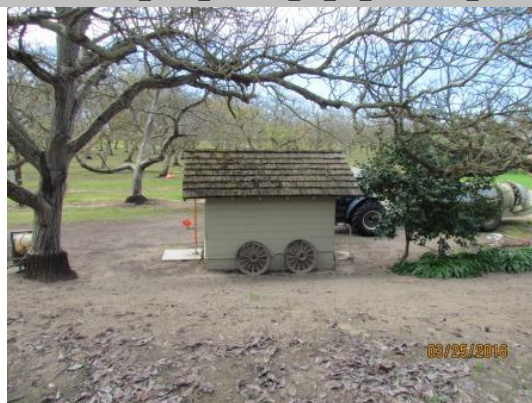
Photo 1 of 1 : SP\_2020\_RD1001\_35\_18\_20200227\_00007.jpg

Shed at landside toe.

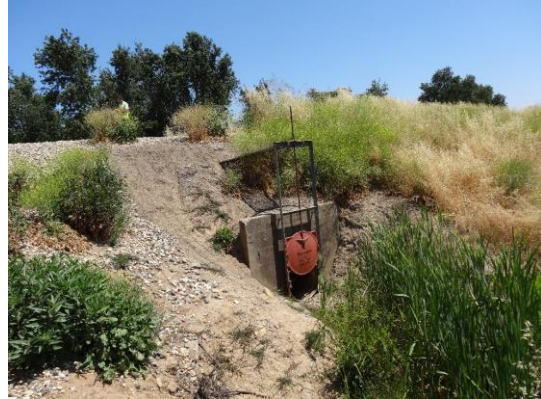
Photo 3 of 3 : UCIP\_SP\_2020\_14008\_23106.jpg

Comment Code						
Inspector Comment						
DS_ID:22543 FS_ID:14008 EP_NO: N/A Repair Type: Non-Urgent Crossing Status: Found UCIP Comments: 05/23/2013 - slide gate in inlet pipe on landside - pits on pipe due to corrosion (P. Amatya - DWR UCIP) FIELD_STRUCT_DESC: 36-inch corrugated metal gravity drainage pipe through the levee, 15 feet below the crown. Flap gate and concrete U-shaped headwall at outfall on the waterside (WS) end. Slide gate at inlet on the landside (LS) end. (Reclamation District No. 1001). [Additional Reference(s): DWR Levee Log, 1993. USACE Sacramento O&M Manual 141.1, August 1955, (Station 67+75)]. FS Date: 5/23/2013

LS- slide gate in inlet pipe structure

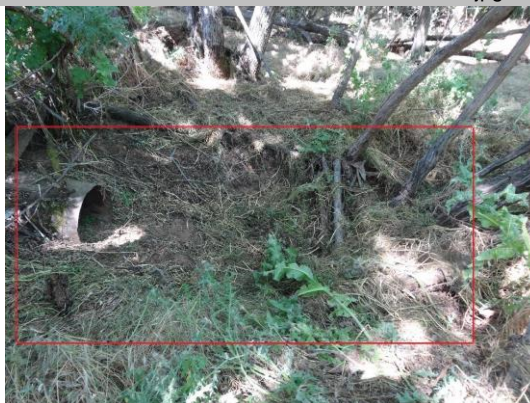
Photo 2 of 3 : UCIP\_SP\_2020\_14128\_23307.jpg

LM Start	0.88	Rating **	M	Issue No.	911
LM End	0.88	Issue Type +	En	Location *	
Category	Supplemental			GPS Latitude/Longitude	
				Start	End
Item	DWR UCIP Field Study			39.006508 °	39.006508 °
				-121.391086 °	-121.391086 °
DWR ID	22549				
Comment Code					
Inspector Comment					
DS_ID:22549 FS_ID:14128 EP_NO: 958 Repair Type: Non-Urgent Crossing Status: Found UCIP Comments: 05/21/2013 - slide gate on WS not found- needs abandoned properly. (P. Amatya - DWR UCIP) FIELD_STRUCT_DESC: *ABANDONED* 24-inch irrigation pipe of an unknown material through the levee, at an unknown depth. Slide gate on the waterside (WS) end. (24-inch irrigation pipe authorized under Permit No. 958, 1944 - Frank B. Lichty and Maggie Lichty). FS Date: 5/21/2013

WS- abandoned CMP and depression around it.

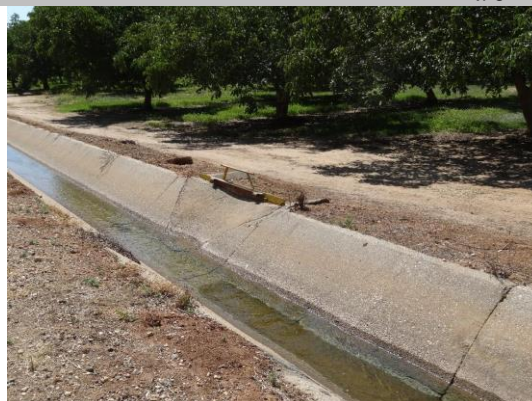
Photo 3 of 3 : UCIP\_SP\_2020\_14128\_23309.jpg

LS- no pipe or structure found on landside.

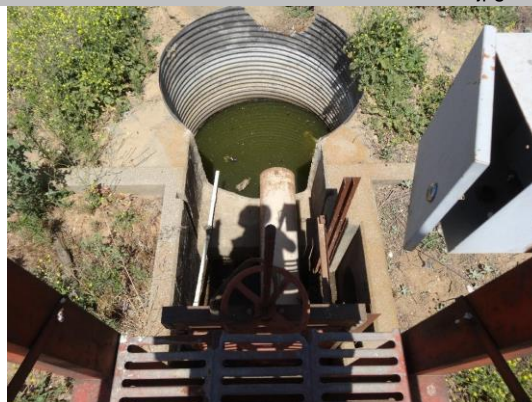
Photo 2 of 3 : UCIP\_SP\_2020\_41727\_23324.jpg

DS\_ID:22561  
FS\_ID:41727  
EP\_NO: 4505  
Repair Type: Non-Urgent  
Crossing Status: Found  
UCIP Comments: 05/21/2013 Two small steel pipes sleeved through 30-inch CMP may be a compliance issue as slide gate cannot close.- this may have been converted into drainage pipe (?) - big CMP standpipe on WS. (P. Amatya - DWR UCIP)  
FIELD\_STRUCT\_DESC: 30-inch concrete encased corrugated metal irrigation pipe through the levee, 11 feet below the crown. Concrete headwall and slide gate at the waterside (WS) toe, removed. Metal walkway on the WS to the slide gate. Pipe discharges into a 48-inch concrete standpipe at the landside (LS) toe. Two vertical pumps. (30-inch concrete encased corrugated metal irrigation pipe authorized under Permit No. 4505, 1964 - State of California, Department of Public Works, Division of Highways). [Additional Reference(s): DWR Levee Log, 1993. USACE Sacramento O&M Manual 141.1, August 1955, (Station 949+00), 30-inch steel pipe referenced].

WS- CMP standpipe, pipes and concrete headwall.

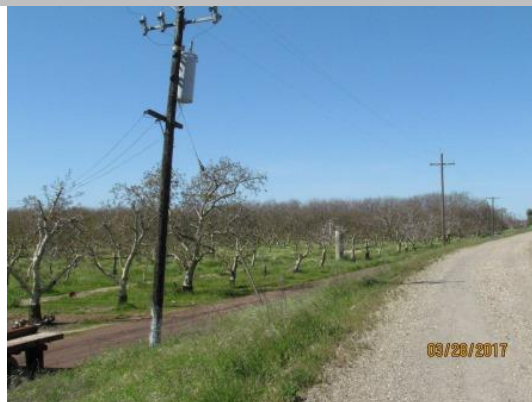
Photo 1 of 1 : SP\_2020\_RD1001\_37\_20\_20200227\_00013.jpg

View looking downstream of unpermitted pole.

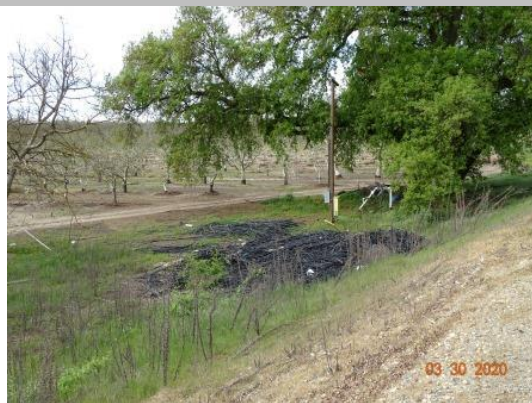
Photo 1 of 1 : SP\_2020\_RD1001\_37\_26\_20200407\_00038.jpg

View looking downstream landside drip irrigation and trash on levee slope, Spring 2020.

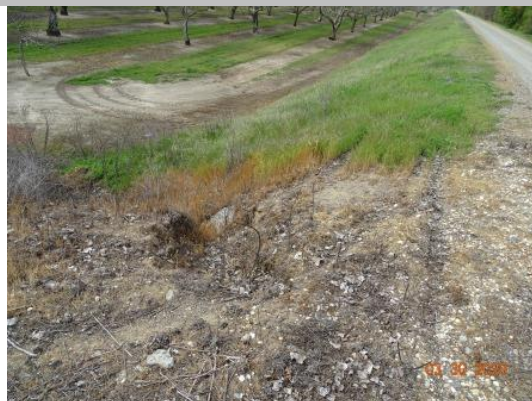
Photo 1 of 1 : SP\_2020\_RD1001\_37\_21\_20200408\_00041.jpg

LM Start	6.51	Rating **	M	Issue No.	21
LM End	6.51	Issue Type +	Ma	Location *	LS
Category	Earthen Levee			GPS Latitude/Longitude	
				Start	End
Item	Erosion / Bank Caving			38.983953 °	38.983953 °
				-121.488081 °	-121.488081 °
DWR ID	DWR_RD1001_03_s_2020_21				
Comment Code					
E2 : Schedule repair of erosion site prior to the next inspection.					
Inspector Comment					
Repair the erosion reel down the levee slope, Spring 2020.

View looking downstream landside at a washout running down the levee slope, Spring 2020.

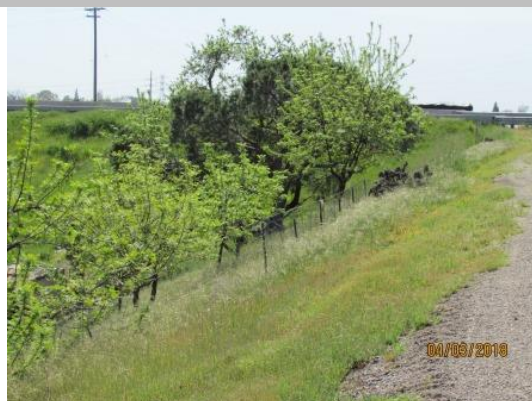
Photo 1 of 1 : SP\_2020\_RD1001\_38\_48\_20200227\_00023.jpg

View looking downstream landside of fence and landscaping that have been placed by the land owner on levee slope.

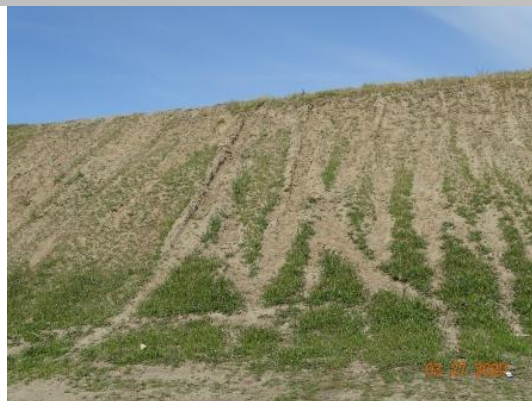
Photo 1 of 1 : SP\_2020\_RD1001\_38\_62\_20200407\_00071.jpg

View looking at the landside levee from the toe at the vehicle tire tracks on the slope, Spring 2020.

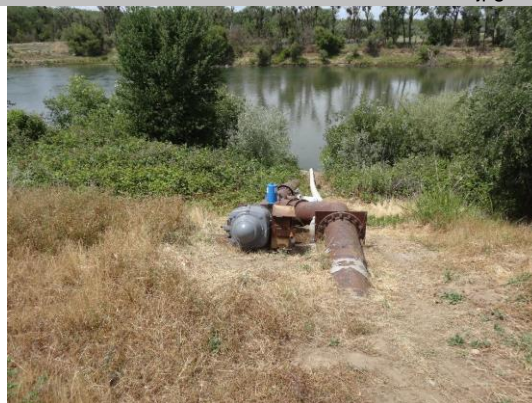
Photo 1 of 3 : UCIP\_SP\_2020\_55167\_24121.jpg

WS- slanted pump and pipe on levee slope.

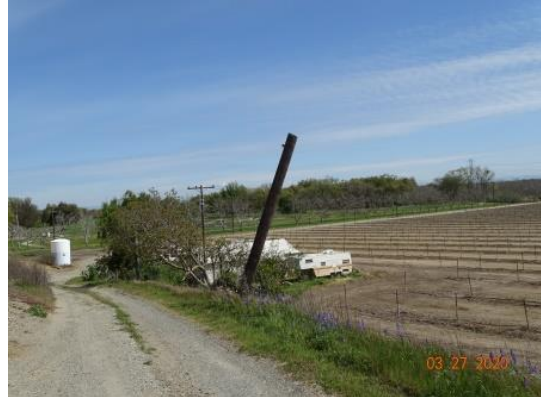
Photo 1 of 1 : SP\_2020\_RD1001\_38\_27\_20200407\_00072.jpg

View of pole on landside, no lines connected to it, Spring 2020.

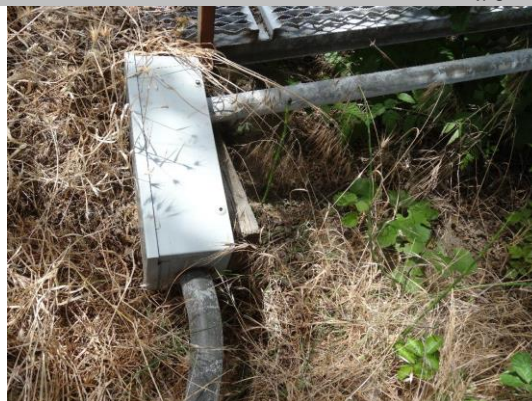
Photo 2 of 3 : UCIP\_SP\_2020\_55172\_24064.jpg

WS- power cable also penetrates the levee. Power cable box near steel walkway

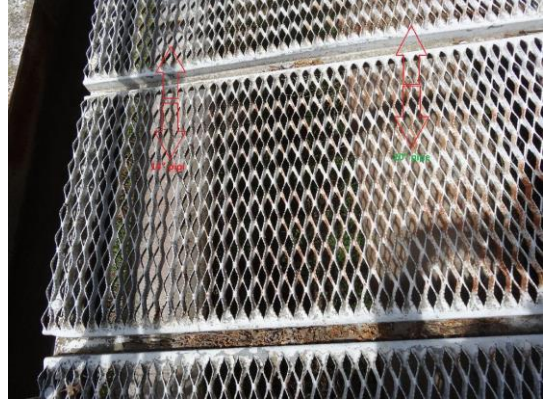
Photo 3 of 3 : UCIP\_SP\_2020\_55172\_24063.jpg

WS- pipes visible through steel walkway deck.

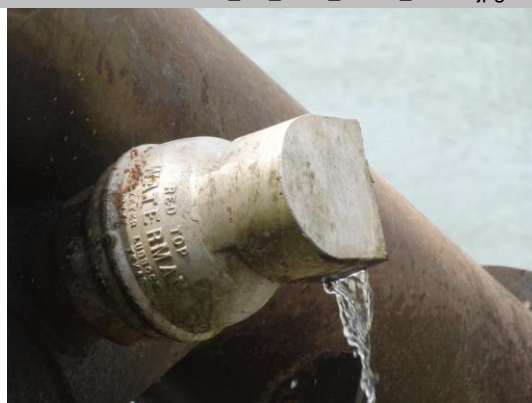
Photo 2 of 3 : UCIP\_SP\_2020\_55174\_24040.jpg

WS- water leaking from air vent on inlet pipe.

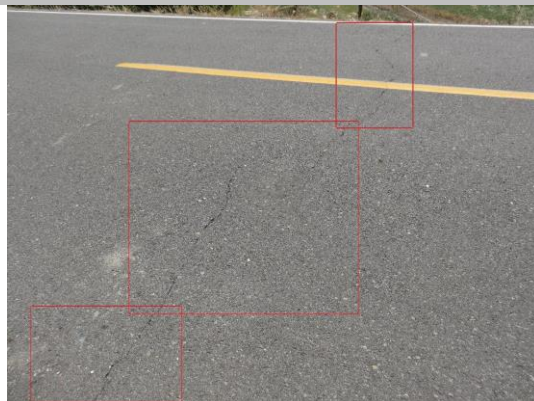
Photo 3 of 3 : UCIP\_SP\_2020\_55177\_24000.jpg

Levee Crown- road surface cracks along the pipe. Needs more investigation.

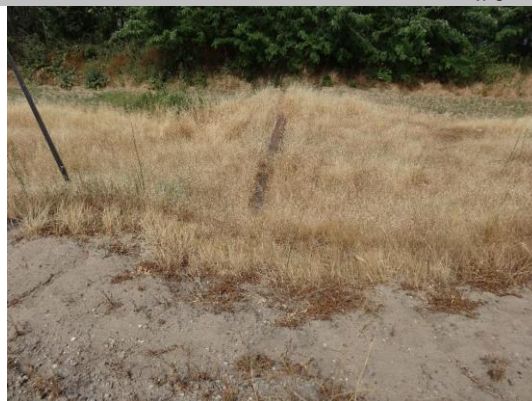
Photo 1 of 3 : UCIP\_SP\_2020\_55178\_23966.jpg

WS- damaged pipe with holes, cracks on levee slope. River bank is not visible due to dense vegetation (top)

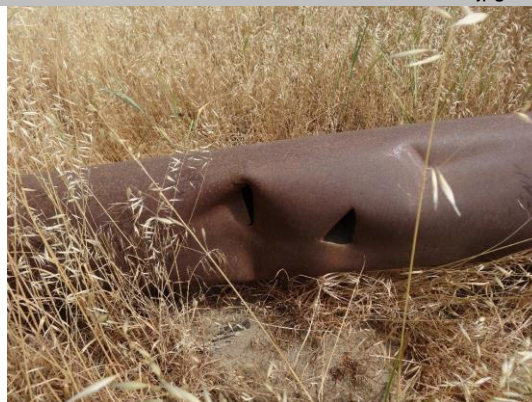
Photo 2 of 3 : UCIP\_SP\_2020\_55178\_23965.jpg

WS- abandoned damaged pipe with holes, cracks on levee slope.

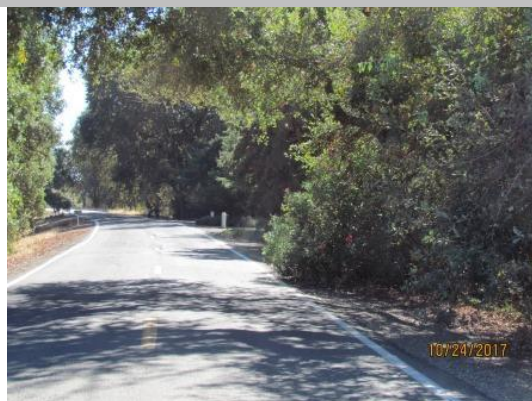
Photo 1 of 1 : SP\_2020\_RD1001\_38\_37\_20200227\_00021.jpg

View looking downstream waterside of landscaping vegetation encroaching onto the levee crown.

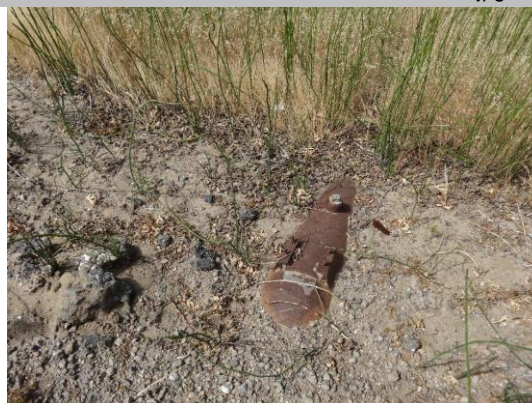
Photo 2 of 3 : UCIP\_SP\_2020\_55179\_24133.jpg

WS- exposed pipe on levee slope.

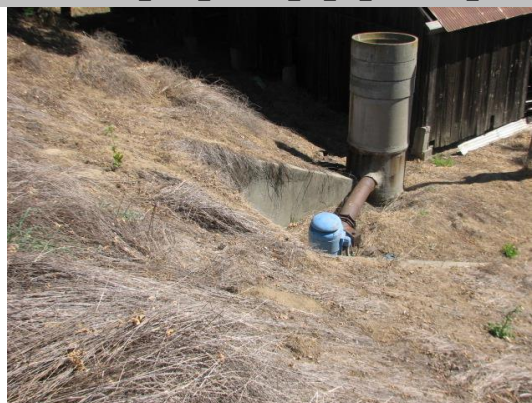
Photo 1 of 1 : SP\_2020\_RD1001\_38\_30\_20200227\_00014.jpg

A retaining wall is within the profile of the slope.

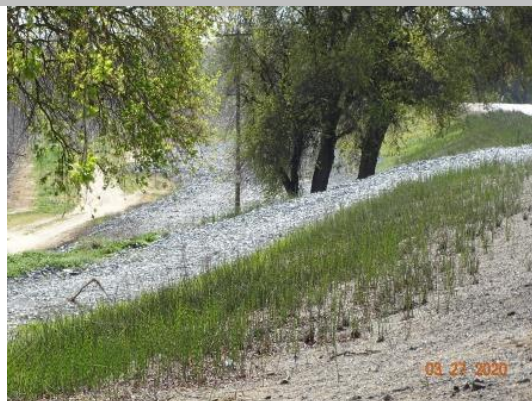
Photo 1 of 1 : SP\_2020\_RD1001\_38\_60\_20200407\_00079.jpg

View looking upstream landside of the seepage berm emergency repair done in 2017.

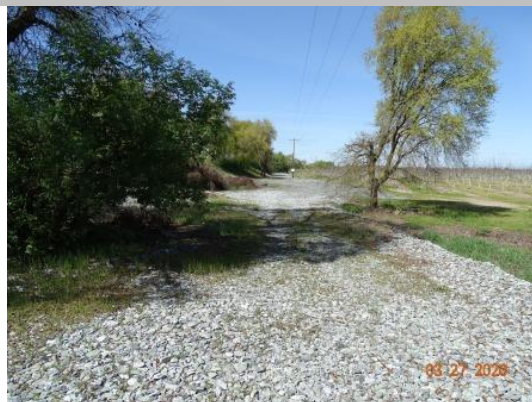
Photo 1 of 1 : SP\_2020\_RD1001\_38\_49\_20200407\_00076.jpg

View looking upstream landside of the seepage berm emergency repair done in 2017.

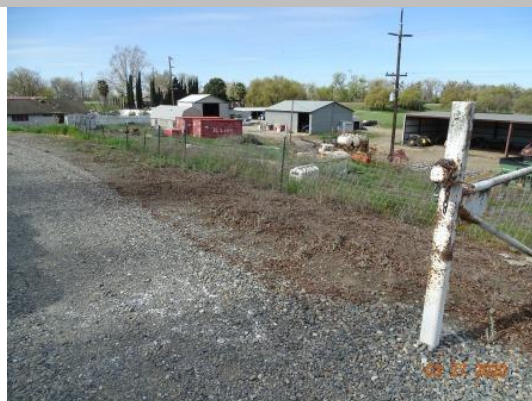
Photo 1 of 1 : SP\_2020\_RD1001\_39\_15\_20200406\_00024.jpg

View looking downstream landside at a temporary goat fence, Spring 2020.

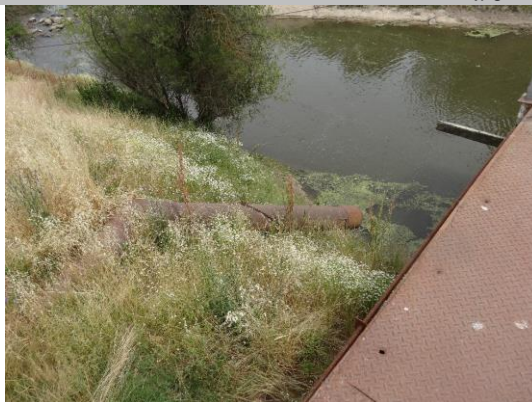
Photo 2 of 3 : UCIP\_SP\_2020\_14486\_23912.jpg

WS- abandoned pipe adjacent to pump station on stream bank.

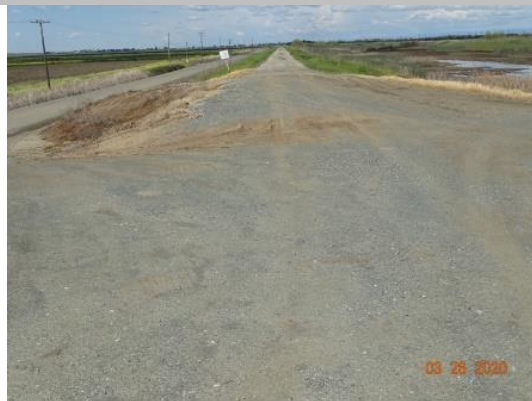
Photo 1 of 1 : SP\_2020\_RD1001\_40\_8\_20200406\_00056.jpg

View looking upstream of crown where there is cross traffic creating a low area in crown roadway, Spring 2020.

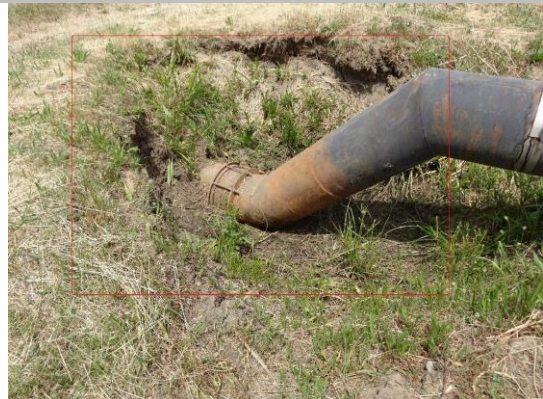
Photo 3 of 3 : UCIP\_SP\_2020\_55201\_23426.jpg

WS- large depression on levee berm at pipe daylight

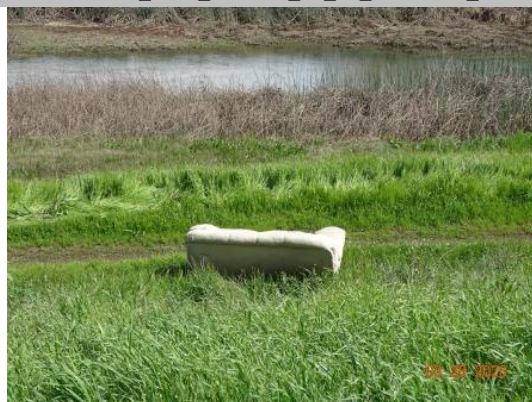
Photo 1 of 1 : SP\_2020\_RD1001\_40\_26\_20200406\_00057.jpg

View looking at the waterside slope where a couch has been dumped, Spring 2020.

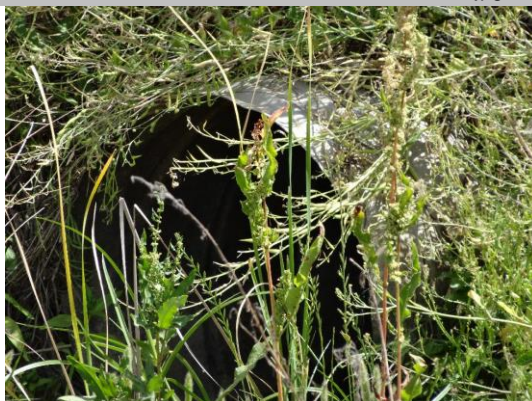
Photo 1 of 3 : UCIP\_SP\_2020\_55206\_23396.jpg

LS- vegetation on CMP end.

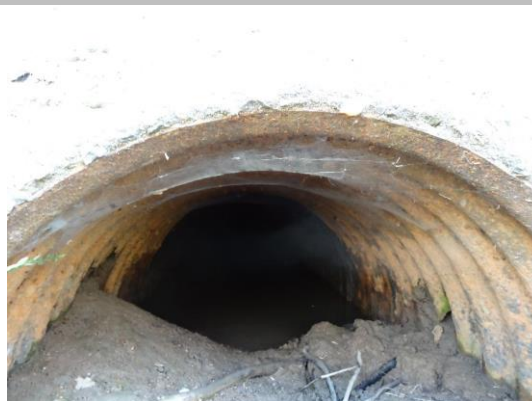
Photo 3 of 3 : UCIP\_SP\_2020\_55209\_22044.jpg

LS- highly corroded and damaged CMP in concrete head/wing wall outlet

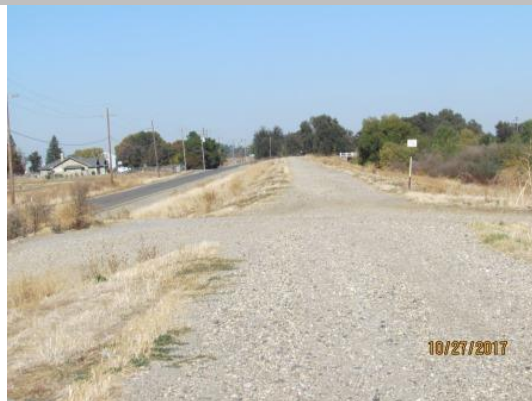
Photo 1 of 1 : SP\_2020\_RD1001\_40\_7\_20200227\_00002.jpg

View of crown where there is cross traffic looking upstream. Monitor this area and fix as needed.

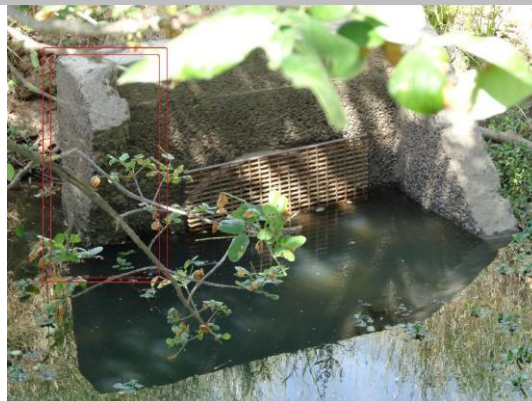
Photo 3 of 3 : UCIP\_SP\_2020\_55210\_22032.jpg

WS- inlet pipe with trashrack in a damaged wing wall

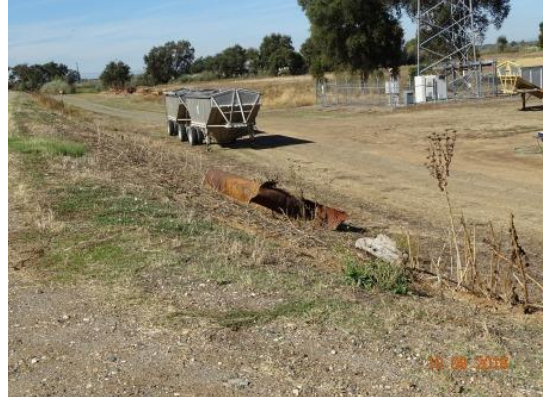
Photo 2 of 2 : SP\_2020\_RD1001\_40\_24\_20200227\_00010.jpg

View of an old piece of pipe still lying on landside levee slope looking downstream. Fall 2018.
